RAIL DEFECTS HEAD CHECKING ON THE SERBIAN RAILWAYS

Zdenka Popović, Ljiljana Brajović, Luka Lazarević, Leposava Milosavljević

Preliminary notes

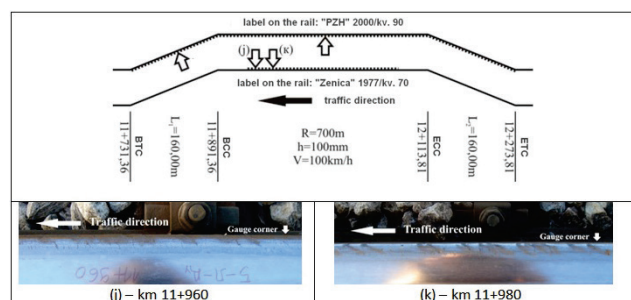
Figure 6 HC defects on the outer and inner rail in a curve

HC defect was observed on both rails (Fig. 6), on the railway section Zemun – Zemunsko polje, in the curve with radius $R = 700$ m (the left track, km 11+731,36 – 12+273,81). This line was designed for maximum speed of 120 km/h, in 1978. The cant of outer rail amounted to 145 mm. Speed was reduced for a long time at 40 km/h due to poor track geometry. Speed was increased to 100 km/h, and the rail cant was reduced to 100 mm in 2011. New outer rail was installed in October 2004. The defect is observed along outer rail in the curve. The defect is medium severe: 4 ÷ 5 cracks/1 cm, crack length of 10 ÷ 20 mm. The defect is observed on most parts of inner rail in the circular curve: 1 ÷ 2 cracks / 1 cm, crack length of 5 ÷ 20 mm. Figure 6 shows PZH rails made by the Chinese producer PZC Steel that are known to be susceptible to corrugation and occurrence of cracks at the driving surface [22].

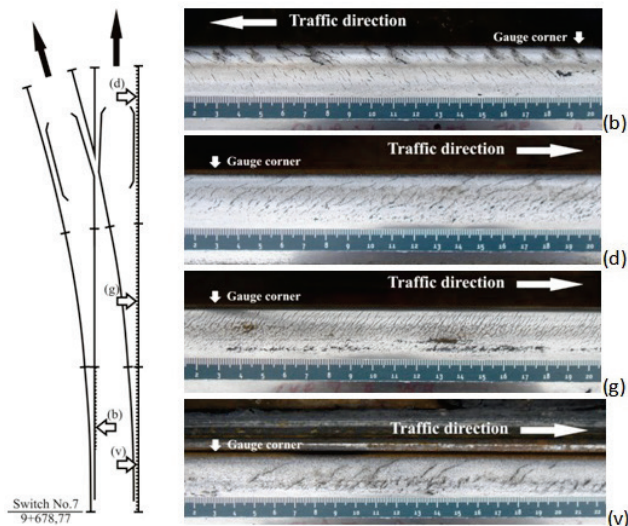
HC defect was also noted in some rail switches in stations "New Belgrade" and "Zemun". The reason for this can be found in irregular track geometry and worn out

elements of switches [21]. The appearance of defects in Fig. 7 is untypical because the HC appeared on the right stock rail and on the right switch rail. A switch was incorporated into the track in 1993. All rails in the switch have the steel quality 700. The severe defects are observed: crack lengths from 5 mm to 35 mm and $2 \div 5$ cracks/1 cm.

Figure 7 Untypical HC defects in the rail number 7 in station "Zemun", km 9+678,77

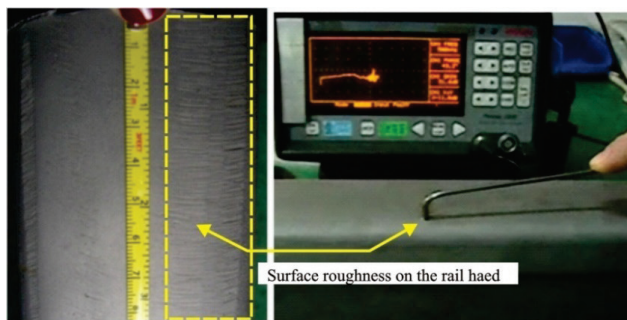
Figure 8 The surface roughness detection using the EC and the rail sample for testing

The rail surface roughness becomes visible after the rail sample treatment by sandblasting in the laboratory (Fig. 8, left). The device for EC testing detects roughness that cannot be detected by visual inspection (Fig. 8, right). EC testing of surface and subsurface defects that cannot be detected by visual inspection is shown in Fig. 9. This proves the importance of grinding of new rails and cyclic grinding.

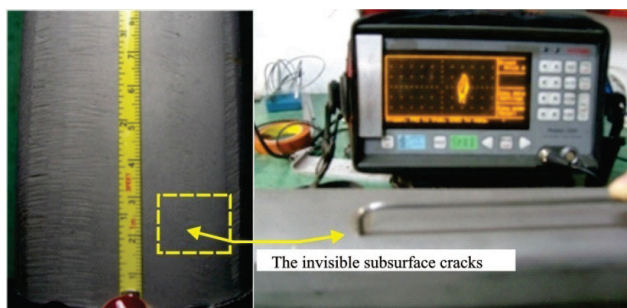
Figure 9 The subsurface cracks detection using the EC and the rail sample for testing
